FACT SHEET NEPAL: SMALL SCALE BIOGAS PLANTS

Project update 2024 – Nepal: Small biogas plants

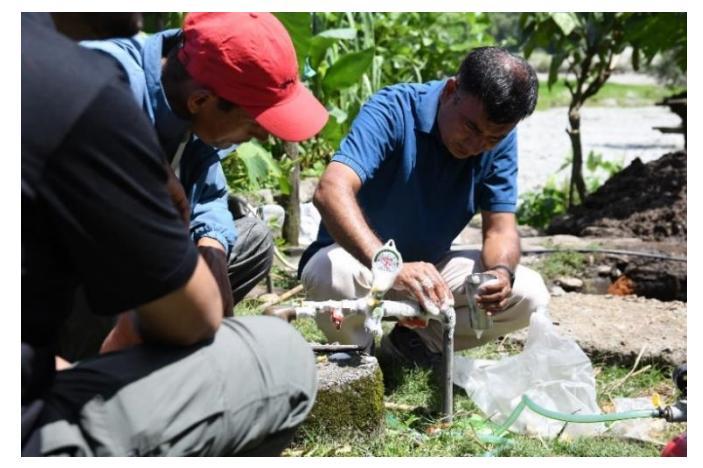
Picture 1: NBPA technicians check gas pipes and replace defective parts

remote households. Before maintenance and repairs are carried out, the repair team discusses the operation of the system and any anomalies with the families. Reduced gas pressure, for example, can be an indication of a leak. The technicians use a compressor and pressure gauge to measure a possible drop in pressure in the pipe system. Leaks are then detected using a soap solution. If small bubbles form, the leak has been found. Damaged parts are replaced immediately. New pipes are also laid directly - often in cooperation with the families.

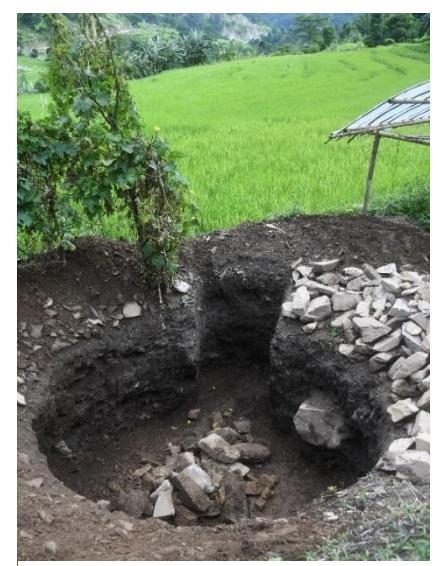
Picture 3: Civil engineering work for new biogas plant

For plants under construction, the management team of local biogas companies supervises the progress and compliance with construction standards. Proper plant sizing is crucial to ensure gas production meets family needs and maximum permissible pressure is maintained.

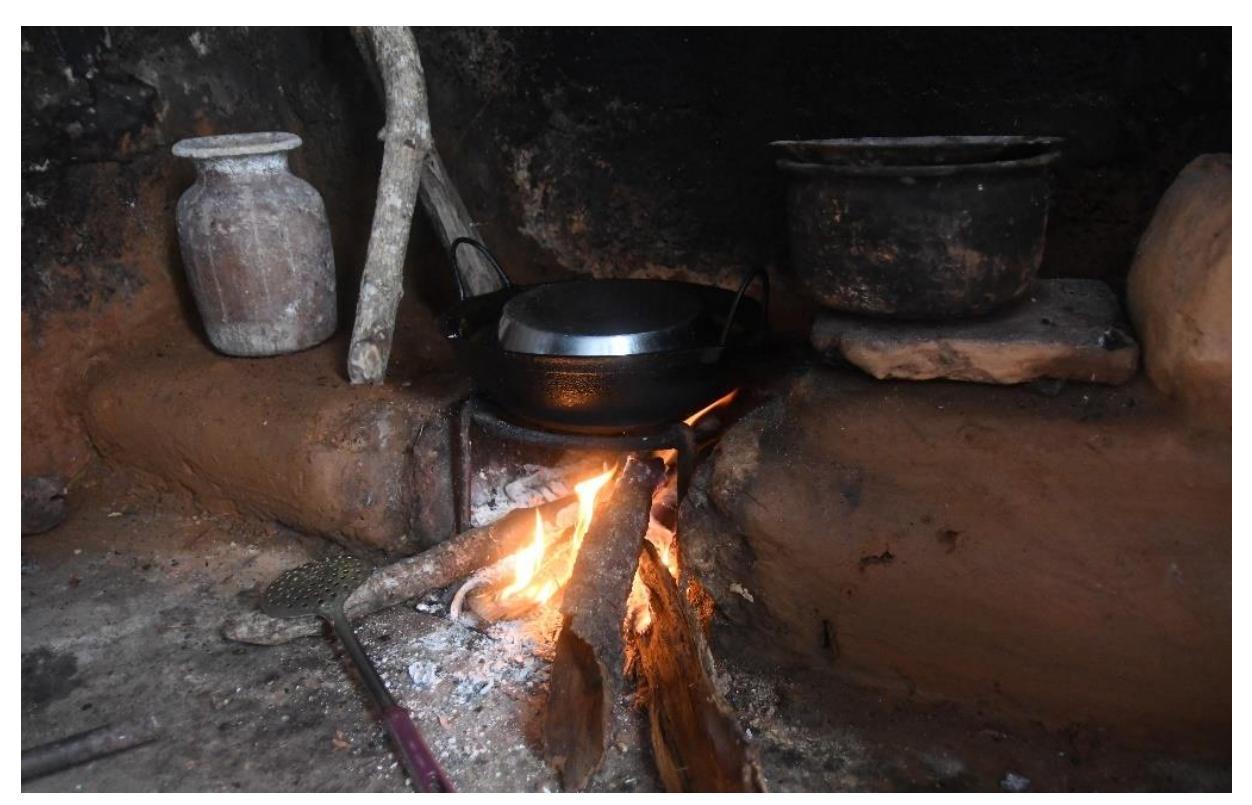
Picture 5: Due to the defective biogas plant, the family has temporarily switched back to firewood

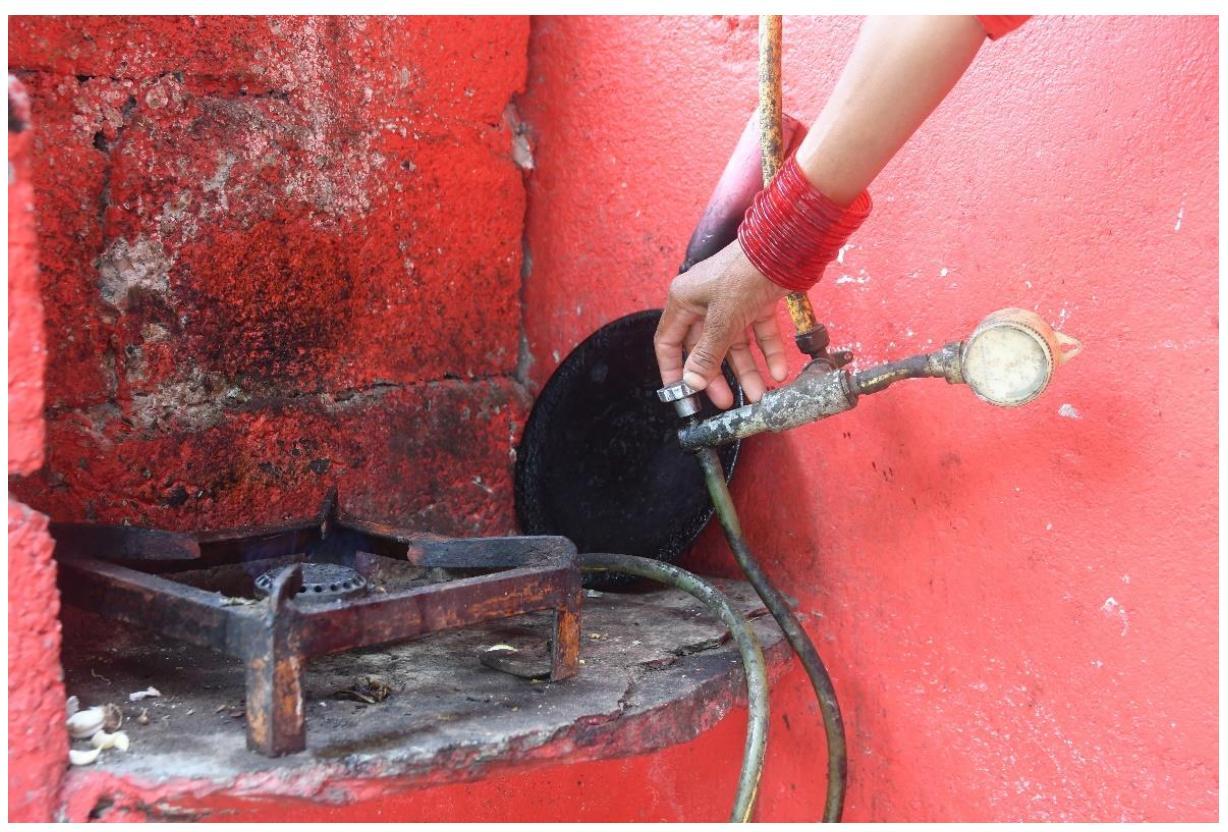
Picture 8: Daily operation of a 25-year-old biogas plant

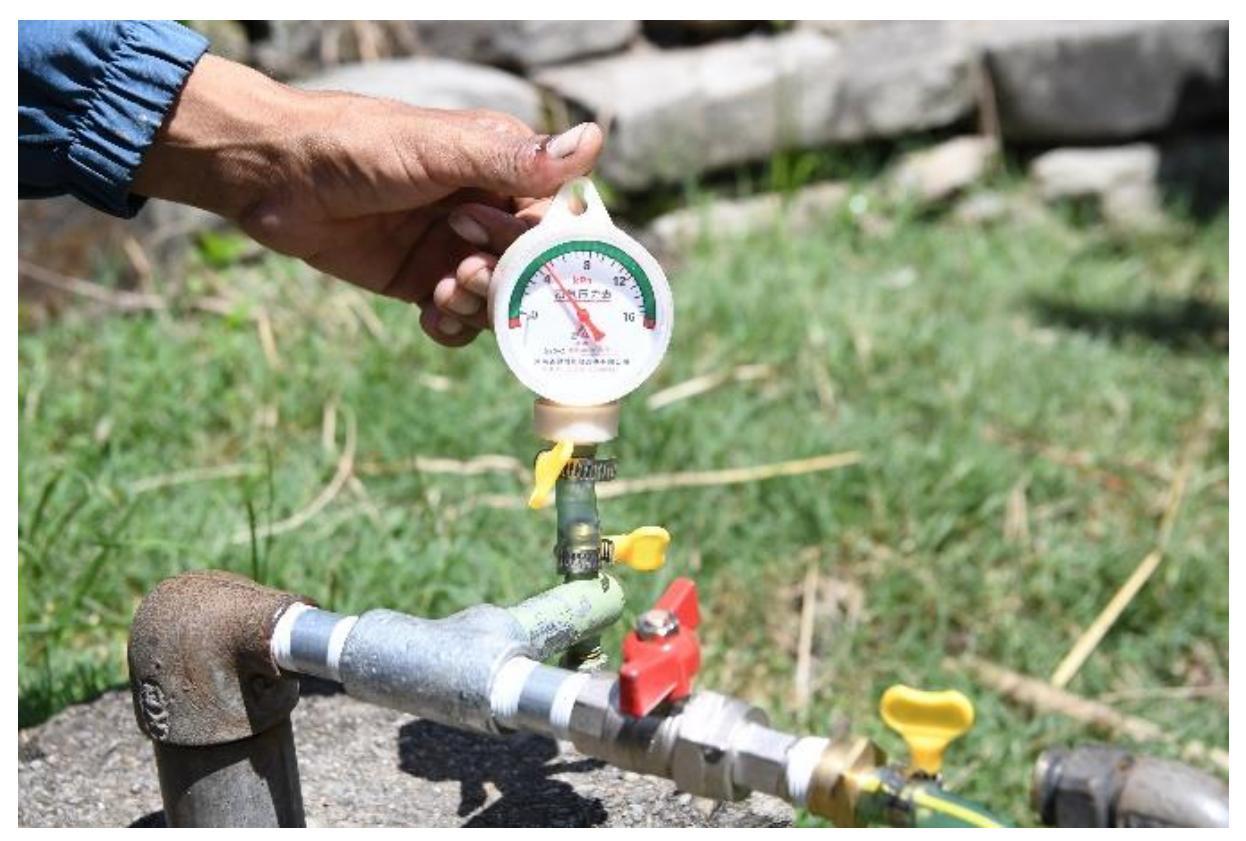
Picture 10: NBPA technician checks the tightness of the pipework system

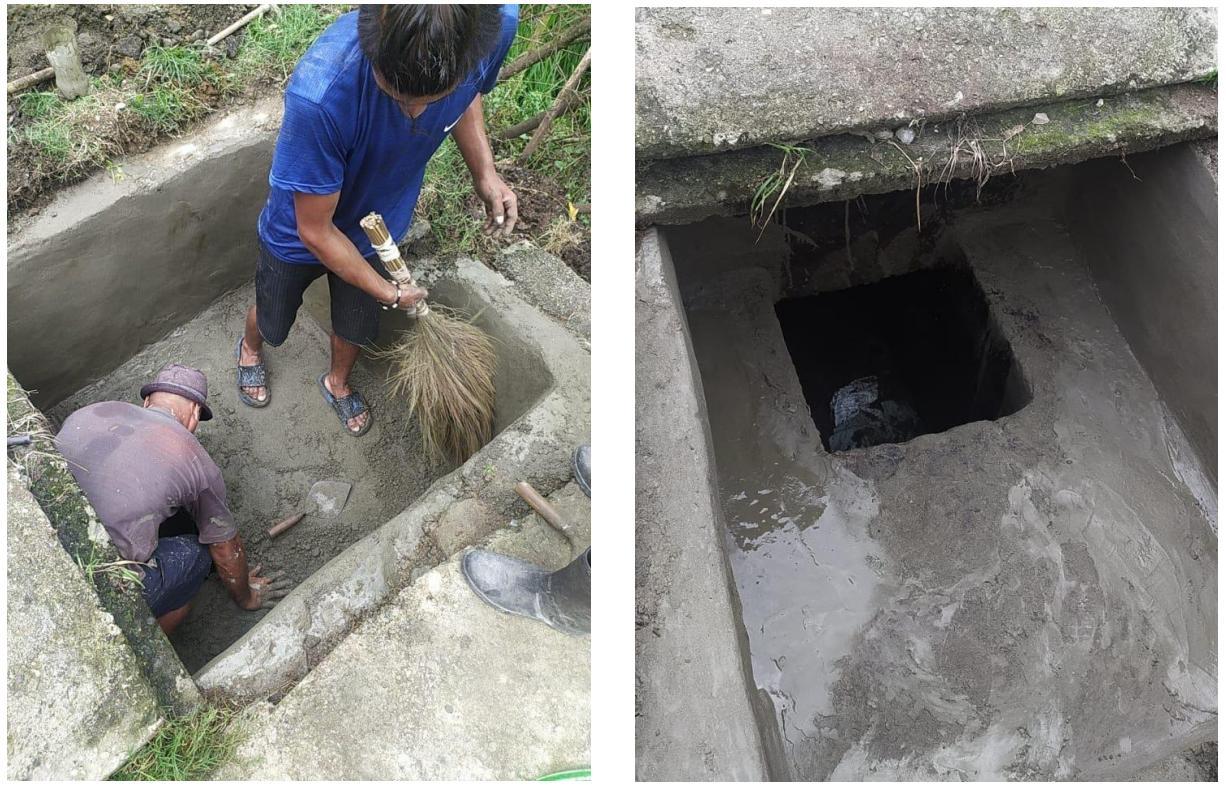
Pictures 11 & 12: NBPA employees renovate old biogas plant

Some plants were completely renewed this year. This involved emptying, cleaning, and resealing the plants. The removed digestate was mixed with fresh material and reintroduced to quickly restart operations. Challenges such as heavy rainfall were met with great flexibility by the team.
